ICOM ID RP-4000V D-Star Repeater Power Control

Author: John M Wysocki. January 2012.

The Mount Climie ICOM D-Star installation consists of an ID-RP-2000V - 145.425 MHz, an ID-RP-4000V - 438.600 MHz repeater and the ID-RP2 Controller.

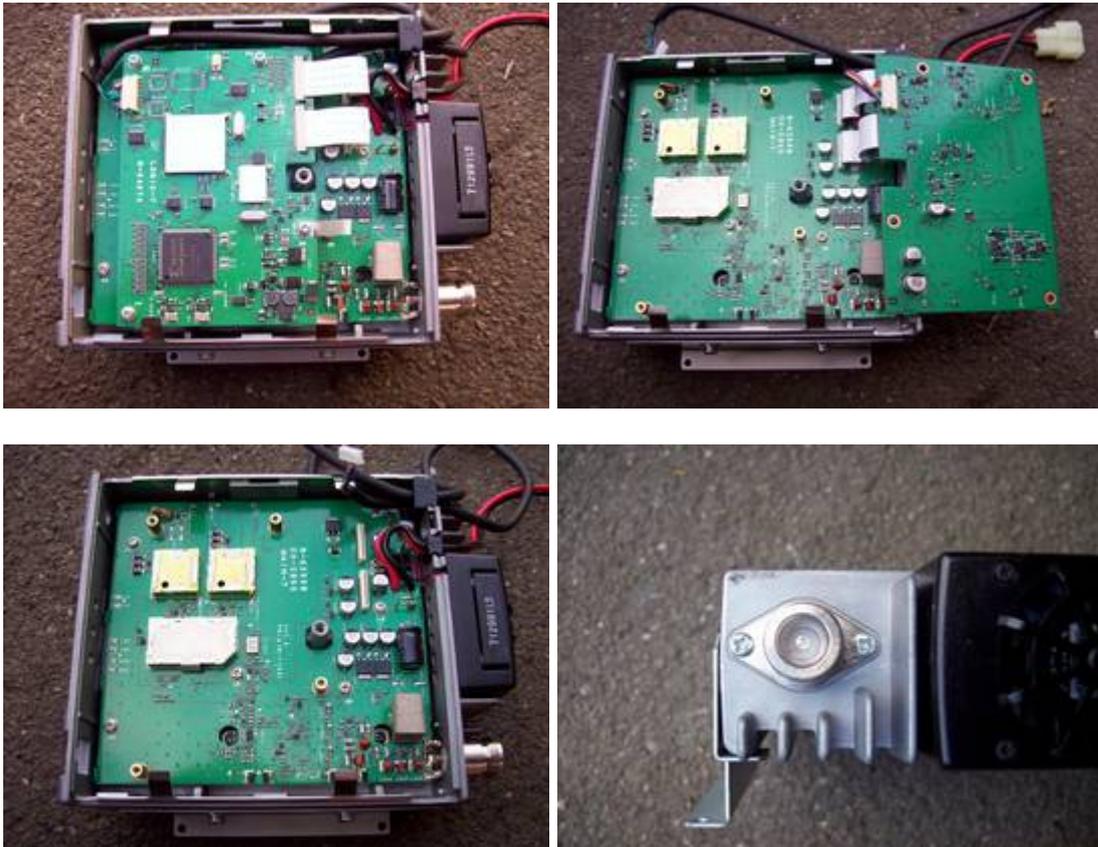
There was obviously a cooling problem. I opened the TX unit and removed all the boards. I found that ICOM have used "fast" type screws with course thread and

not machine screws with fine tread. These screws were not torqued down tight and in my opinion this was the cause of the bad ground.

Swarf was found inside the connector and the center pin connection to the PCB was only 1mm to 2mm from the PCB ground. The connector was also not in line with the RF PCB connection and only bridged with a solder blob.

The following photos show the disassembly of the boards and connector Swarf.

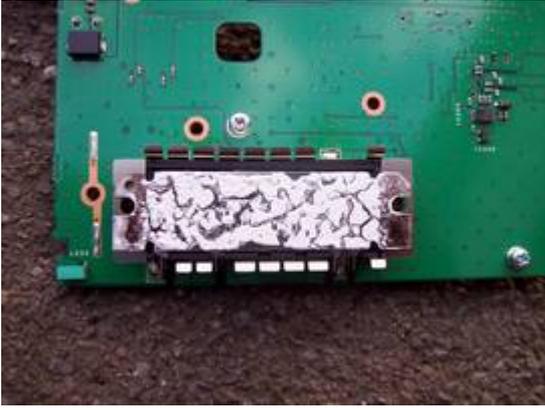
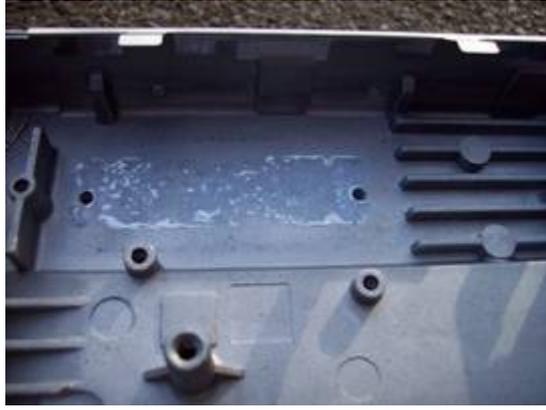
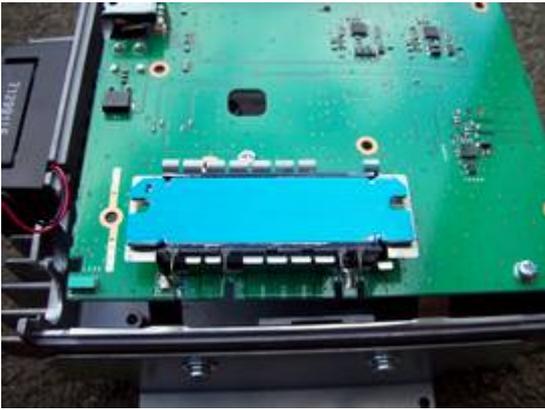
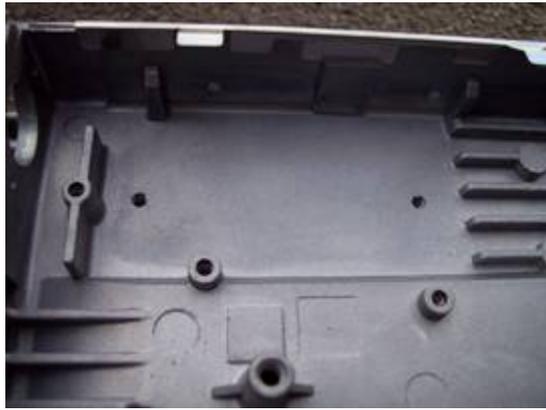
The power block heat sink surface is not milled flat and has a rough surface. Excess heat grease was used and has melted and pooled into hard lumps.

I had to remove all the grease due to not being able to smooth any of it out. The power block is a 30W unit part number RA30H4047M.

I have applied an even surface of Dow Corning 341 blue heat transfer paste as seen in the following photos.

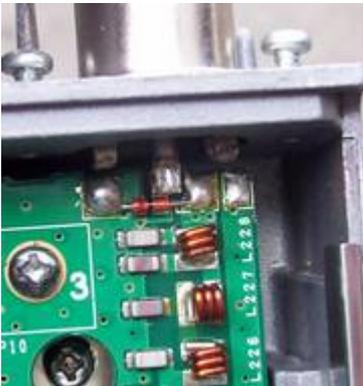
N connector earth and center pin use solder bridges. Center pin almost touches earth pad under the protection device. Sold wire links are now fitted. Center pin was cut on an angle so that the left side, as seen in this photo, was clear of the earth.

The N connector on the back has metal swarf as seen in the above photo. Clearing this out and also trimmed the center pin back away from the earth under the diode could have been causing an SWR fold back to occur.

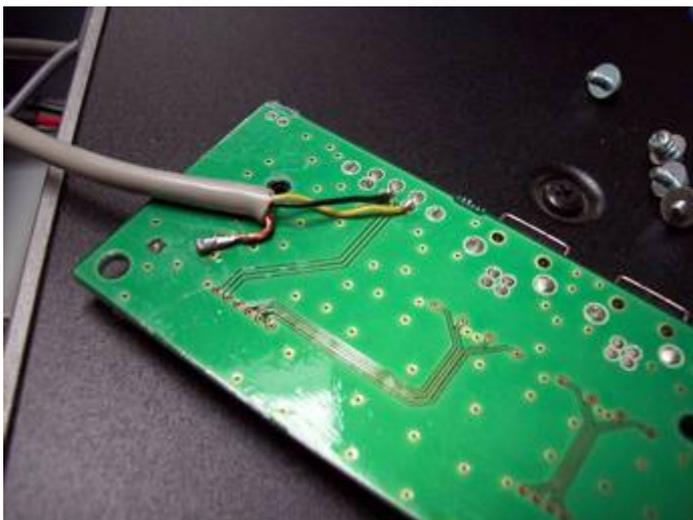
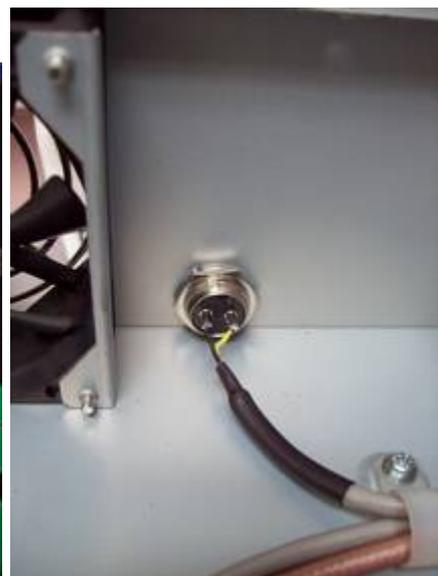
The following pictures show the PCB connection and rear panel socket. Screened two core cable is used. A ground is soldered on the PCB end only.

A plug socket arrangement has been fitted and wired across the H/L front panel power switch. This reduces the RP-4000 to 2.5W during power outages. There is an output on the Innovative SR-250C PSU that closes a contact during power blackouts to save on battery capacity. Remote power control reduces the current from 6.0A to 2.5A. This allows the D-Star system to run for longer during long power outages. The stand-by current is 0.5A.

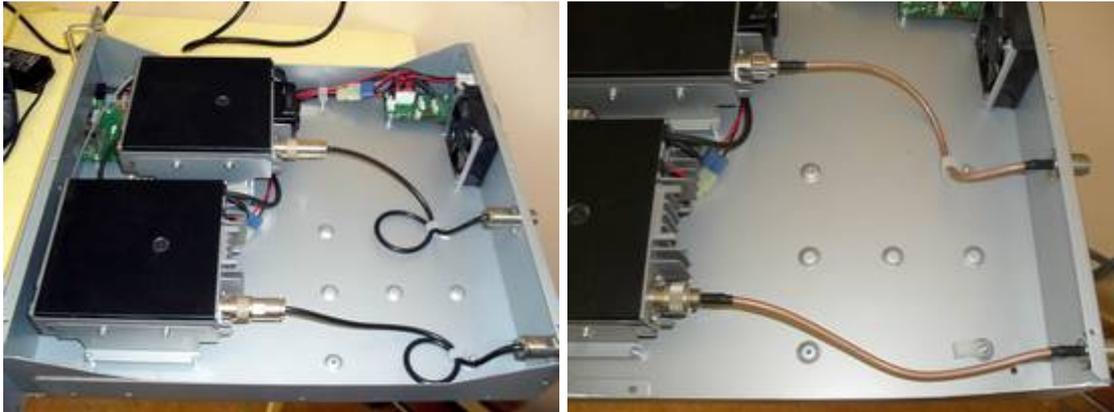
While the RP-4000 was opened up the opportunity was taken to replace the internal RG-58 coax cables originally fitted by ICOM. RG-142 cable is used as replacements. Cross talk causing desense is eliminated using the higher quality screened RG-142 cables. I was not able to measure the difference as I did not have appropriate test equipment but others around the world have and posted this alert on the internet. Having built duplexers I know that RG-58 is a lossy cable used on UHF and the braid is not woven tight enough to prevent cross coupling. The following pictures show the before (black cable) and after (fawn colour cable)

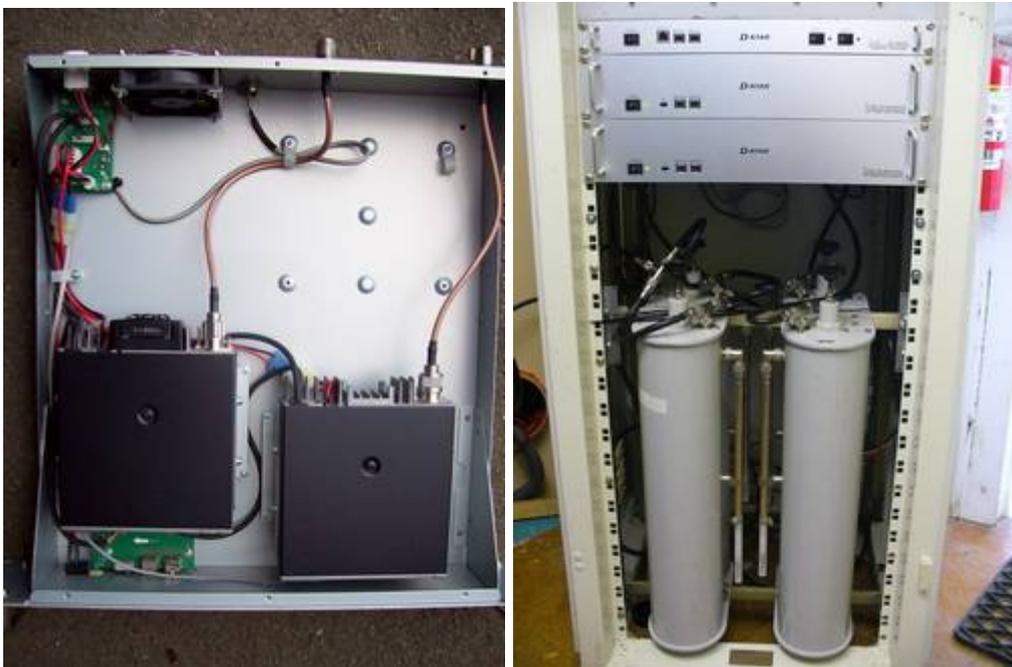
The following are pictures of the completed modified RP-4000 and the MT Climie D-Star rack installation.
