## ZL2VH Newsletter – November 2019

## **Mount Climie 730 antenna pole RF Earth install and testing** *by John M . Wysocki ZL2TWS*

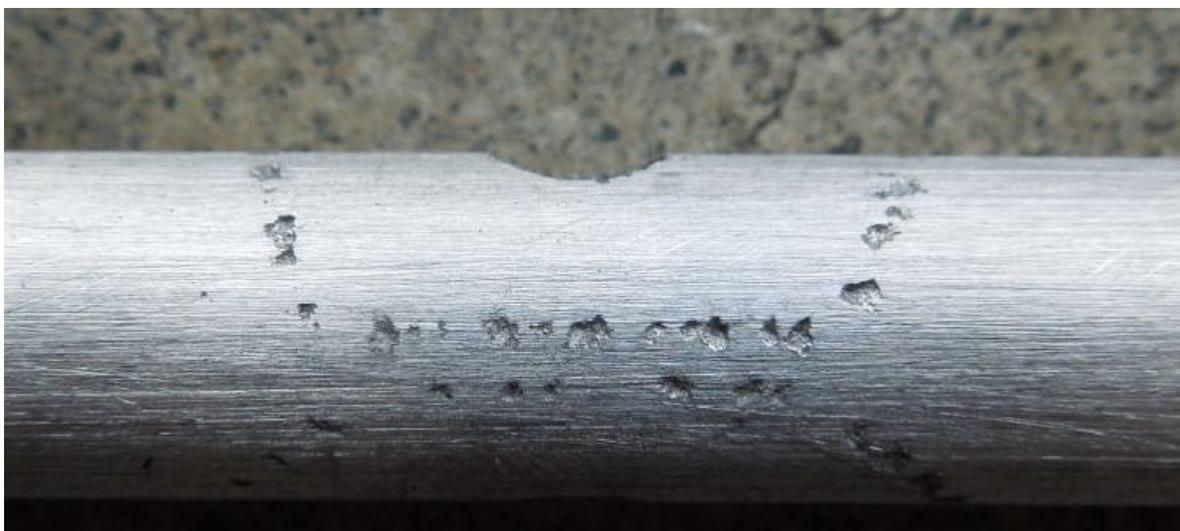
Electrolysis corrosion is also seen at dipole joints. This indicates current flowing at the RF neutral potential connection to the horizontal mounting boom seen in Picture-2.

Picture-2: Dipole to boom corrosion pitting.

The antenna was then stripped down to find that the epoxy filled balun connection used a mounting through bolt to earth the coax braid to the antenna horizontal boom. The method is used commercially to ensure a good ground for unbalanced feeder cables.

Unfortunately in our case discharge current used this path as a better earth all the way back to the south hut main AC earth.

The dipoles have been stripped and cleaned.

New traditional 4:1 coaxial baluns have been made and epoxy filled connections boxes without braid grounding were made as seen in Picture-3.

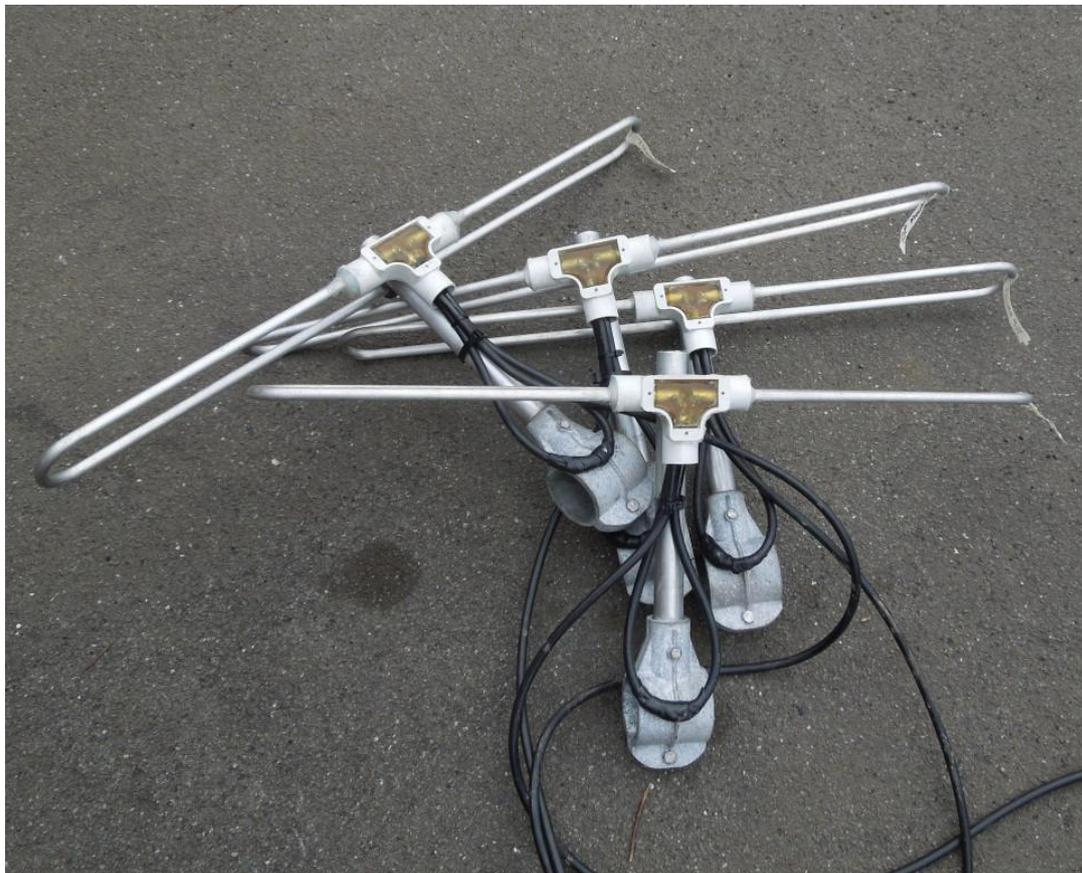
Picture-3: Rebuilt dipole set.

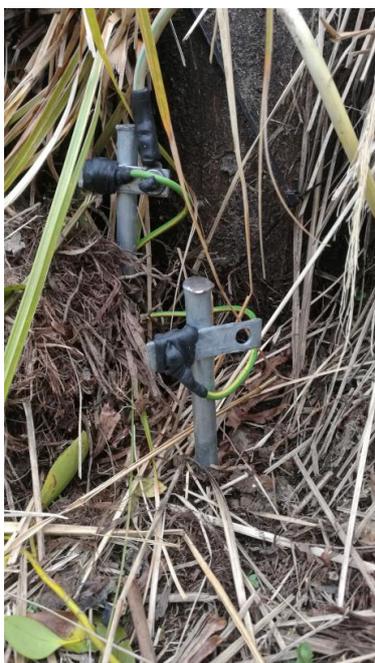
Picture-4: Earth stakes in parallel 29th September 2019.

The earth loop impedance should read better than 200 ohms as an internationally accepted value.

Our test is 106 ohms when the stakes were driven. This is expected to go lower in wet conditions and be high during the summer.

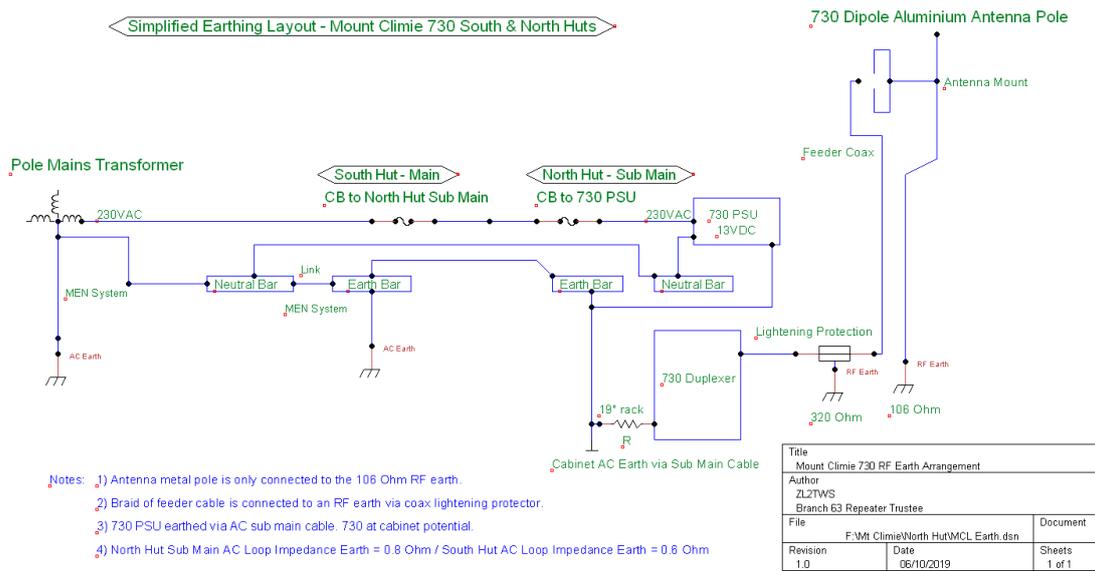
Picture-5: Shows the test arrangement at Climie.

Braid grounding is now done via a lightning arrestor and individual earth stake. (Picture-5).

The idea now is to use a new RF Station earth connected to the aluminium dipole mast pole and have the coax cable braids isolated from carrying the discharge current via the coax and duplexer to south hut AC station earth. The earth leakage tester used is the Aegis CZ20500.

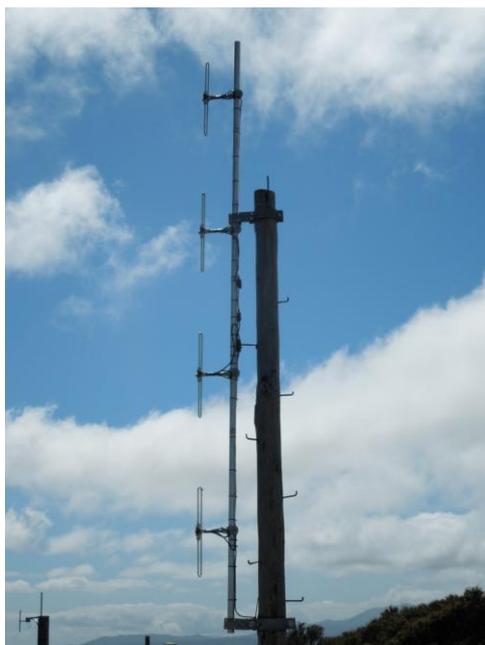
New dipoles are now in service with an omni directional pattern of 5.7dbD and gaining increases of up to 8.7dbD resulting in the reflector effect from the mounting pole. (SkyMast Specifications).

Picture-6: New 730 antenna stack 6th October 2019.

A gain increase was measured in Lower Hutt between the single folded dipole and the four di-pole stack of 8db.
