## **RP-2000 D-Star Repeater at Mt. Climie: Overload & QRN Solution**

Author: John M. Wysocki. December 2014.

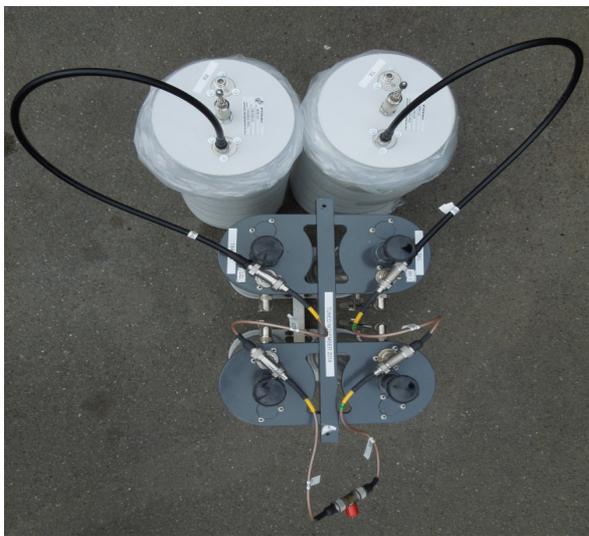
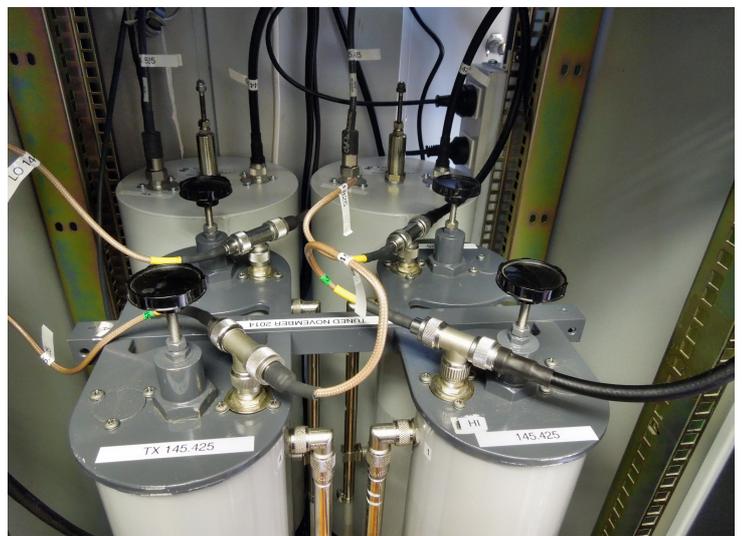
WP-639 duplexer was also stripped down for cleaning. The finger stock was found to be badly worn out and silver plating missing at the critical tuning positions. The duplexer was disassembled and re-plated. New finger stock was sourced by JAG electronics in Canada.

The following pictures below show the completed duplexer and additional cavity filters.

Quickly a solution was found with the addition of two 8 inch high Q cavity filters added to the TX and RX ports between the duplexer and the repeater.

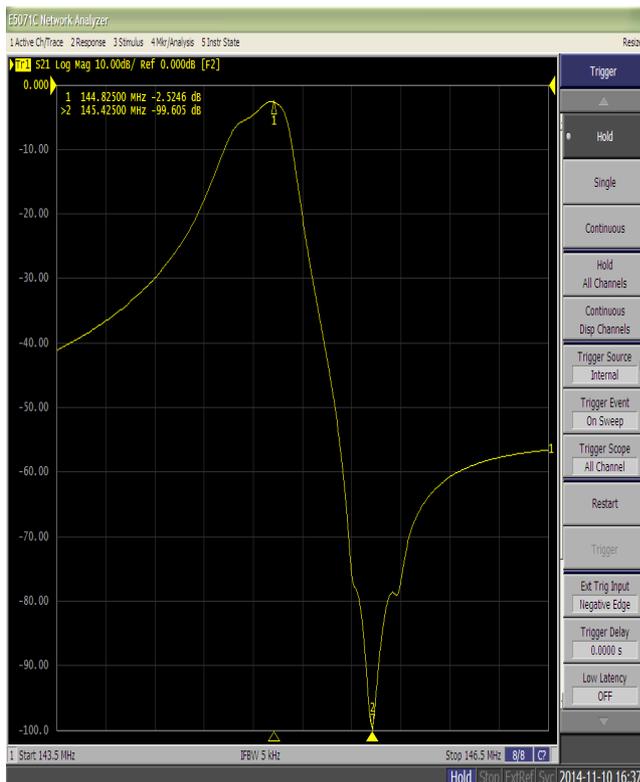
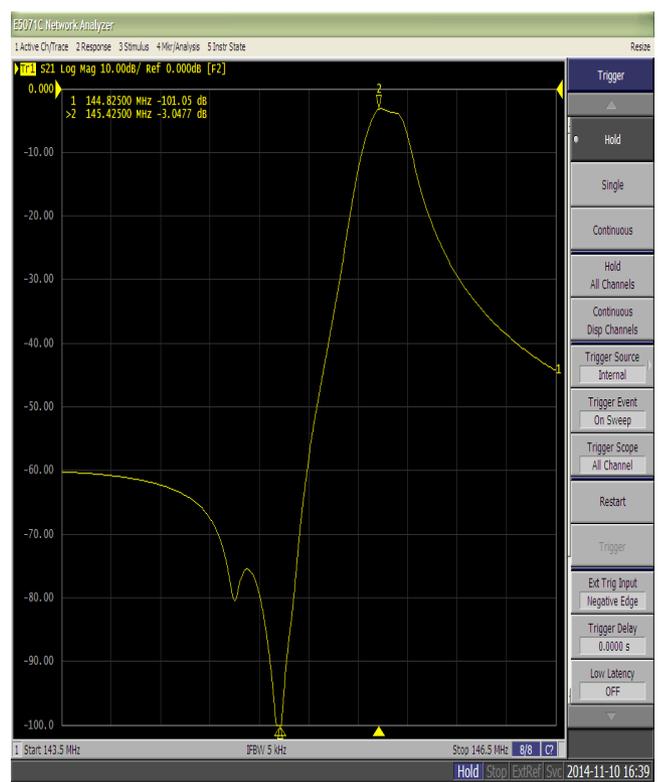
These pictures show the completed duplexer tune performance. -100dB notches.
