ZL2VH Newsletter – June 2018

A BRIEF HISTORY OF THE NEW ZEALAND ZC1 HF MILITARY RADIO TRANSCEIVER by Chris Underwood

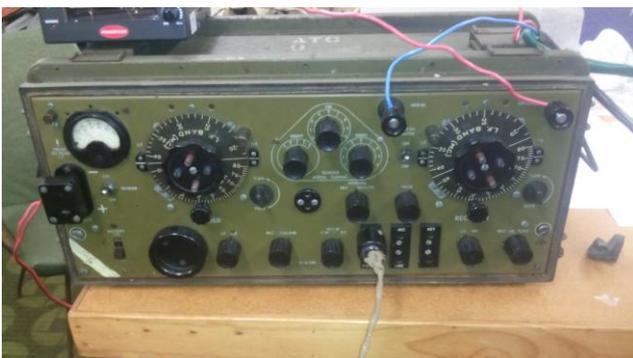
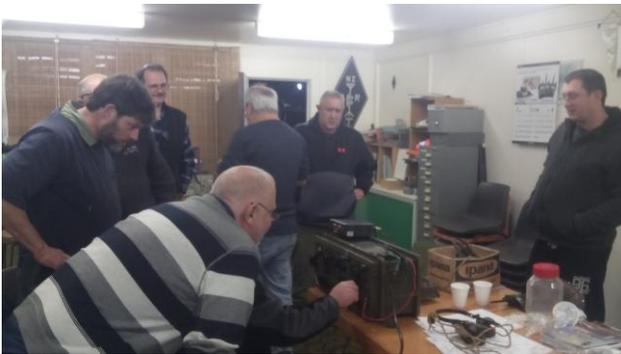
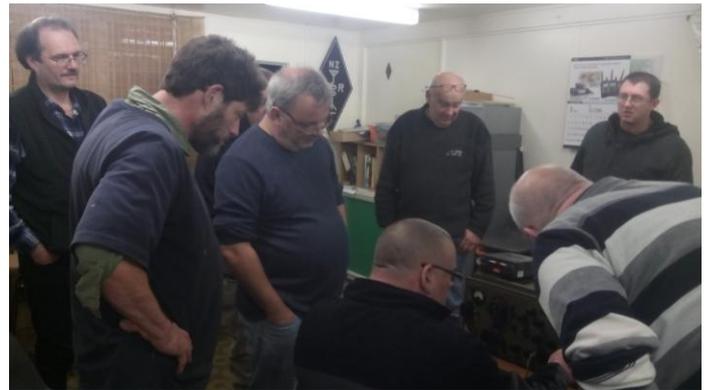
Recently, Liam ZL2BGT brought along his ZC1 Mk2 radio and demonstrated that it still worked – at least in part. This prompted a lot of interest as can be seen in these photos.....
